REINFORCED PLASTIC CONSTRUCTION METHODS FOR LARGE ROCKET MOTOR CASE

VOLUME IV TU-290 CASE DESIGN AND FABRICATION

FINAL TECHNICAL ENGINEERING REPORT
DECEMBER 1963

THIOLKOL CHEMICAL CORPORATION
WASATCH DIVISION
BRIGHAM CITY, UTAH

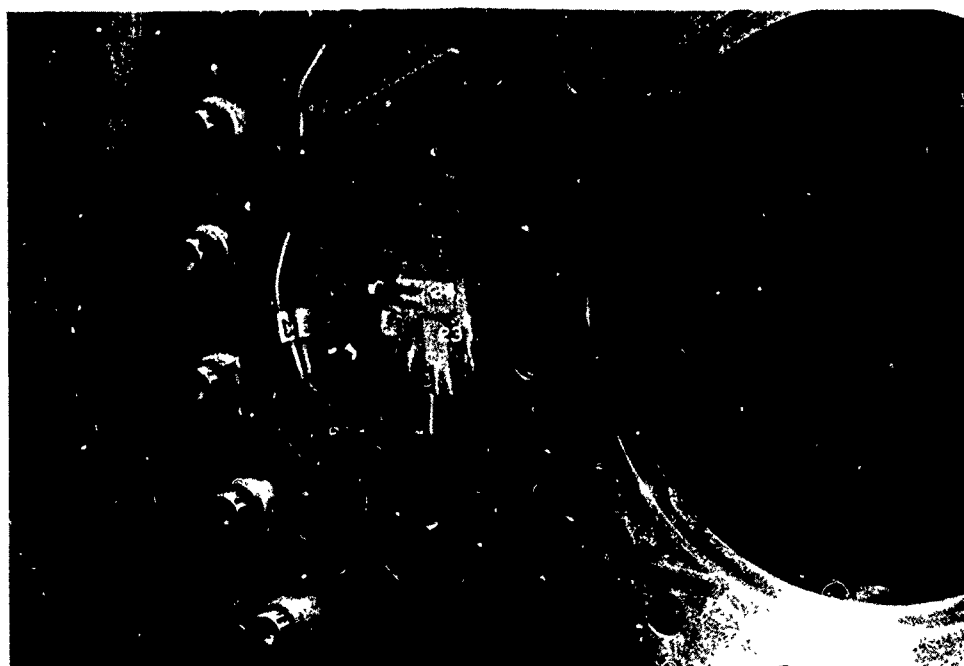
Figure 9. TU-290 Case No. 1 Forward Dome Instrumentation

Indicators 18 thru 22

Indicators 23 and 24

Baldwin PA-3 strain gages (Baldwin-Lima-Hamilton, Waltham, Mass.) were used to measure case growth. The gages were attached to the case with a cement which maintained a bond until the fiberglass was stressed beyond its yield strength. Baldwin AF-7 gages, similarly cemented, were used to measure strain in the PYROGEN igniter cover. Longitudinal and radial case deflections were measured by linear potentiometer indicators (connected to 20 gage piano wire encased in Teflon tubing wrapped around and fixed to the case). Forward dome deflections were measured relative to the forward skirt, and aft dome deflections were measured relative to the aft skirt. The locations of these measurement devices are shown in Figures 8 thru 10.

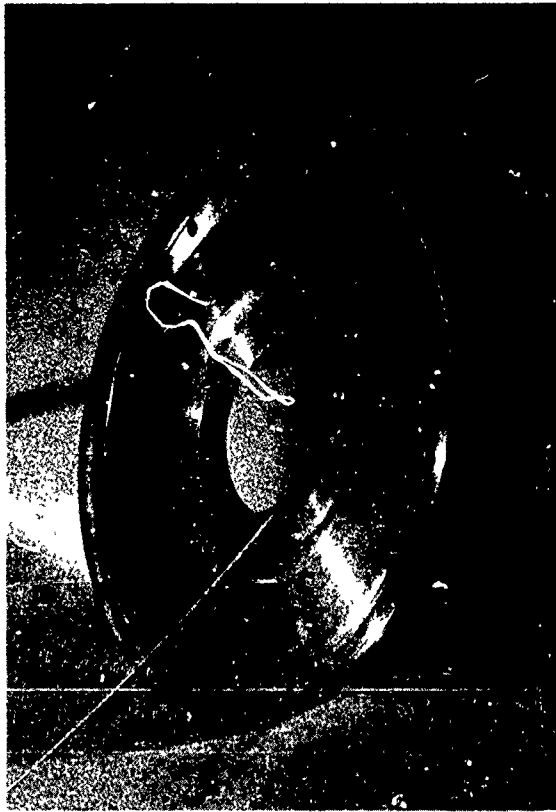
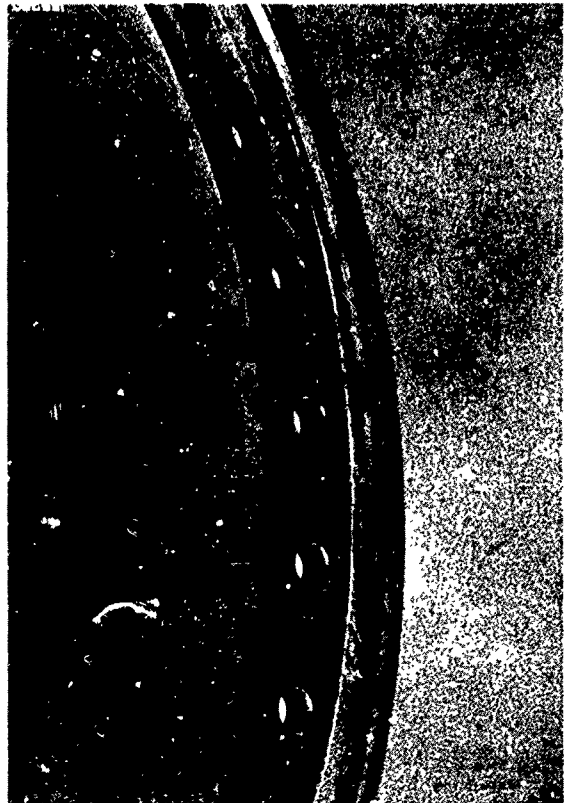
Figure 23. TU-290 Case No. 2 Cover Plate Shear Lip Failure

FORWARD COVER PLATE
SHEAR LIP FAILURE

SHEAR LIP FAILURE
DETAIL

While the failure of the shear lip did not cause ultimate strength failure of the cover plate nor loss of case pressure, the forward polar fitting was permanently deformed due to imposed stresses above yield strength after shear lip failure (Figure 24).

3. The PYROGEN igniter cap must be redesigned to prevent the shear lip from cracking.
4. Methods of adjusting case growth and skirt restraint to prevent premature failure in the case-dome-skirt area must be studied and included in the design of case No. 3.
